***United States Court of Appeals
for the Second Circuit***

HELLENIC LINES LIMITED,

LIFE INSURANCE CORPORATION OF INDIA,

EXHIBIT VOLUME

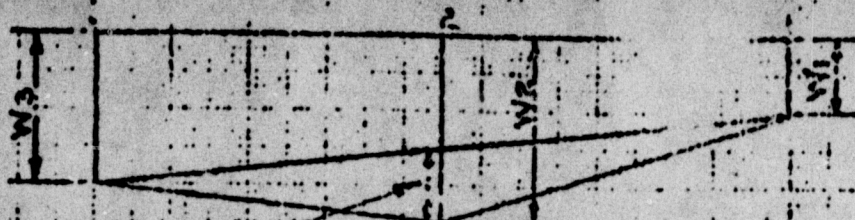
FIG. (i)

- (a) Consider Bearing Nos. 1, 2 and 3.
- (b) Plot wear-down readings W_1 , W_2 and W_3 as shown in Fig (i).
- (c) Join the lower ends of the lines W_1 and W_3 by a straight line as shown, the projection of W_2 below this straight line should not exceed 0.015 inches.
- (d) Repeat for Bearings 2, 3 and 4 as shown in Fig (ii), in this case the projection of W_3 should not exceed 0.015 inches.
- (e) Repeat for Bearings 3, 4 and 5; 4, 5 and 6 as necessary.

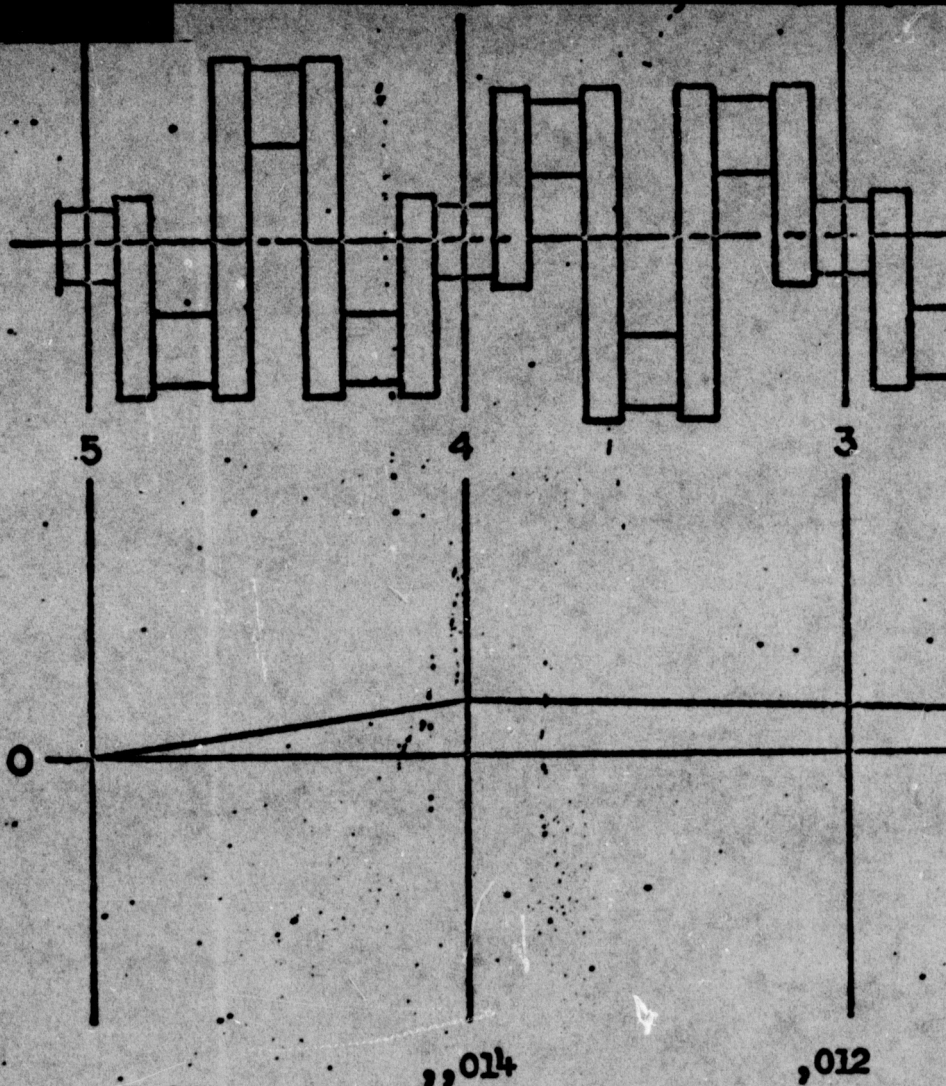
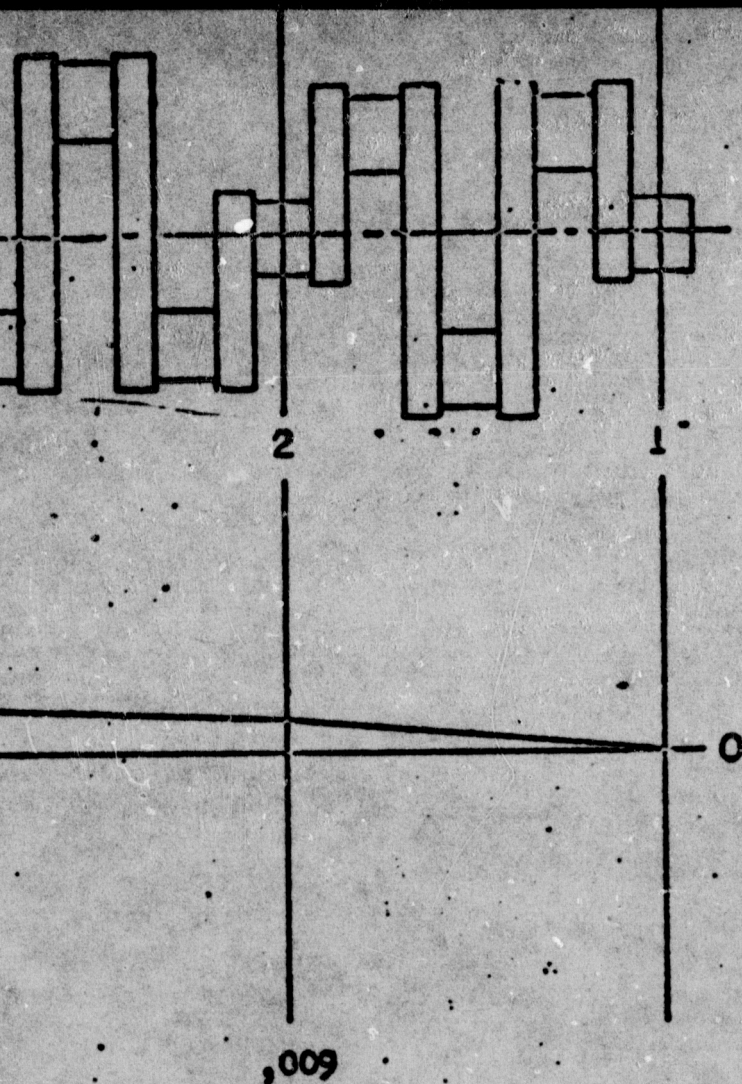
Conditions as found upon arrival on board recorded and result of readings upon completion of work recorded and charts of results of findings furnished.
